THE HANFORD SITE

Hanford Double-Shell Tank Tank Integrity Program Update

Dusty Stewart (ORP)
Karthik Subramanian (WRPS)

January 8, 2020

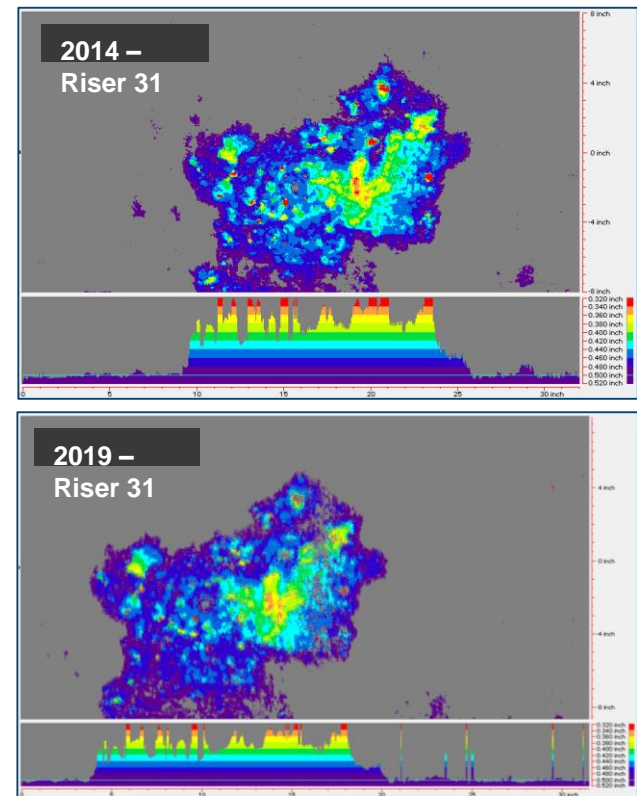
Tank AP-102 Annulus Floor Inspection

- Reinspected at half the normal frequency to evaluate the secondary liner condition
- Examined Tank AP-102 secondary liner floor beneath four risers (Risers 30, 31, 60, and 61)
- Deepest measured pitting locations from Riser 31 in 2014 haven't changed, given the fidelity of the inspection

| Riser | 2019 Area Scanned | 2019 Minimum | 2014 Minimum |
| 30 | ~33 ft ² | 0.459" (8.2%) | 0.486" (2.8%) |
| 31 | ~25 ft ² | 0.142" (71.6%) | 0.149" (70.2%) |
| 60 | ~23 ft ² | 0.451" (9.8%) | N/A |
| 61 | ~13 ft ² | 0.415" (17%) | N/A |

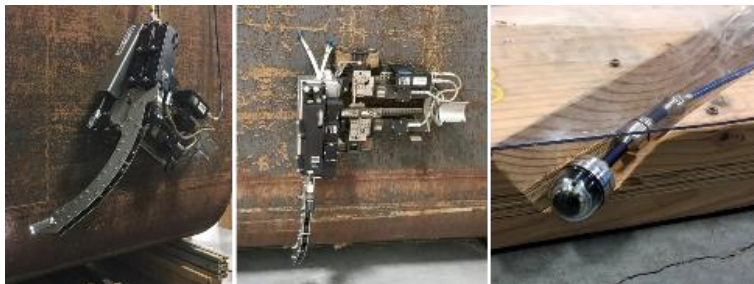
- Tank bottom visual inspection has been incorporated as a programmatic practice since initial demonstration at Tank AP-107
- Has been deployed in Tanks AP-107, AP-108, AN-102, AP-106, AP-102, and AW-102 with great success
- As expected, results show intact metal with evidence of superficial spotty humid air corrosion
